Light Aircraft Crash – A Case Analysis of Injuries

Adi Friedman MD¹, Yizhar Floman MD¹, Shabtai Sabatto MD², Ori Safran MD¹ and Rami Mosheiff MD¹

Objectives: To present our experience in treating five survivors of a light aircraft crash that occurred in August 1995 near Jerusalem.

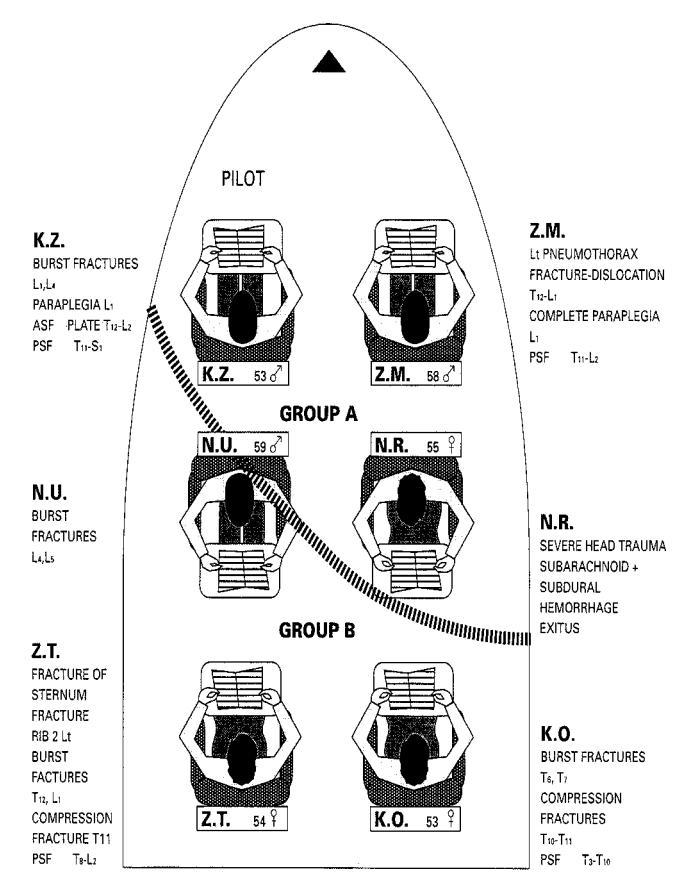
Figure I. Sitting position of the passengers in the aircraft PSF = posterior spinal fusion the collision with the rock on this side. The pilot and the passenger sitting next to him wore a three-point lap and shoulder harness. The third member of Group A (N.R.) was sitting facing backwards. The three passengers in Group B wore lap belts only. Their injuries were less severe, and none of them had significant neurologic sequelae.

Figure 1 shows the position of the passengers in the aircraft. At the moment of the crash, the pilot and the passenger sitting next to him were equipped with a three-point lap and shoulder harness system, while the other four passengers had lap belts only. The two middle seats (of the six passenger seats) were facing backwards.

By drawing an oblique line through the aircraft body [Figure 1], we can divide the passengers into two groups. Group A comprises the severely injured passengers (one dead, the other two paraplegic), whereas in Group B the injuries were less severe. The passengers who were sitting at the front on the right-hand side of the plane (Group A) received most of the crash energy because of
